Manhole Inspection Summary

Manhole # S3700_032MH

Insp Date: 1/30/07 11:25 AM

Location Address: **2209 GREENMOUNT AVE**

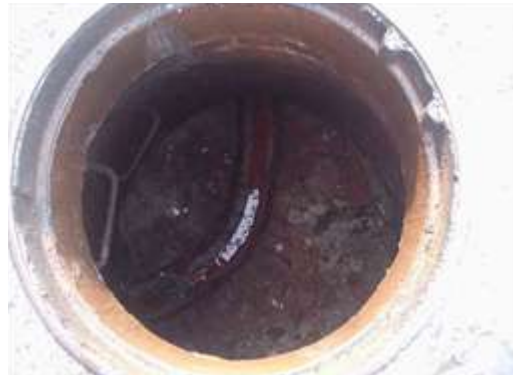
Top View

Corroded steps. Evidence of surcharge - Bench debris.

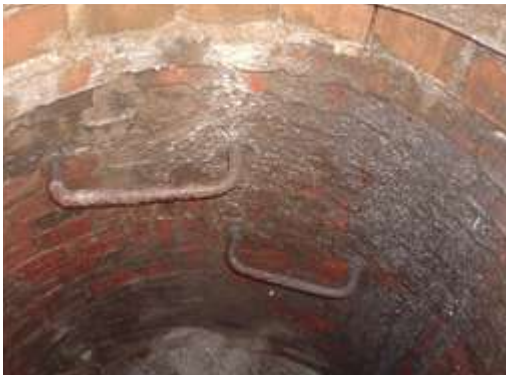
Defect

Frame leaks. Adjustment, Corbel and Barrel infiltration.

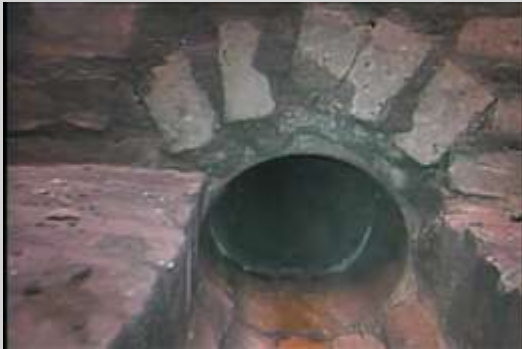
Pipe Out @ 12 O'Clock

8 in. Circular Gravity Sewer

Pipe Material: **Clay** ☐ Pipe Lined

Invert Depth: **6.63** (ft.) Flow Characteristics: **Slow**

Infiltration: **None** Pipe Seal Cond: **Unknown**

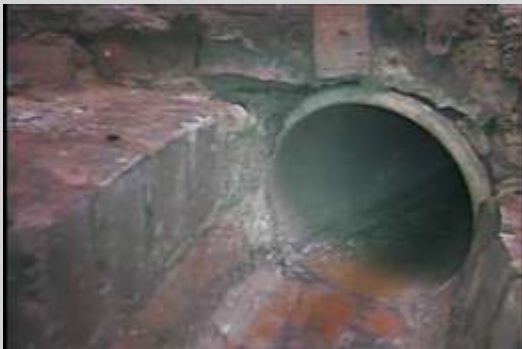
Pipe In @ 8 O'Clock

8 in. Circular Gravity Sewer

Pipe Material: **Clay** ☐ Pipe Lined

Invert Depth: **6.60** (ft.) Flow Characteristics: **Slow**

Infiltration: **None** Pipe Seal Cond: **Unknown**
